Towards Autonomous Inspection of Concrete Deterioration in Sewers with Legged Robots

Hendrik Kolvenbach¹, David Wisth², Russell Buchanan², Giorgio Valsecchi¹,
Ruben Grandia¹, Maurice Fallon², Marco Hutter¹

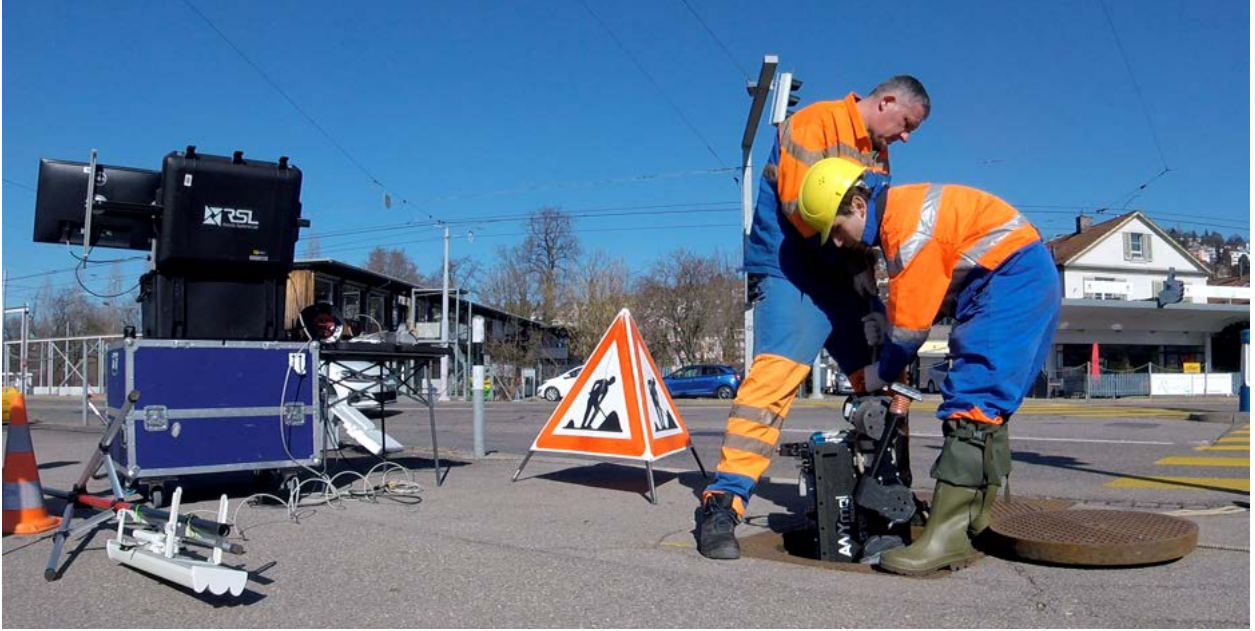
Figure 3: Depiction of the field test setup and the deployment of *ANYmal* into the sewer. The operator base station and warnings signs are visible in the background.

We conducted multiple field test campaigns in the sewage system of Zurich to iterate the hardware, practice operations, collect datasets, and execute inspection missions. The first test campaign with the robot took place during two days in February 2019 [Kolvenbach et al., 2019] the second campaign took place on three days in December 2019. Generally, the robot can be easily deployed through a standard utility hole ($d = 0.8$ m). To do so, the robot's legs are unpowered, tucked up, and the system is lowered into the sewer with a tether (Figure 3). During our tests, the robot was operated from a base station which was located outside the sewer, nearby the utility hole.

The base station consists of the operator PC, an additional screen, and outlets for electricity and communication links to the robot. The base station is easy to transport and quick to set up. We installed a gazebo to shelter the robot operator and desk during rainy testing days. We deployed directional Wi-Fi antennas (Ubiquiti airMAX, HyperLink HG4958DP-19P) into the utility hole via a tripod with reversed column to enable a reliable communication link to the robot. During the test, a safety operator stayed in the sewers with a professional inspector and communicated with the robot operator outside via two-way radios (Figure 4).

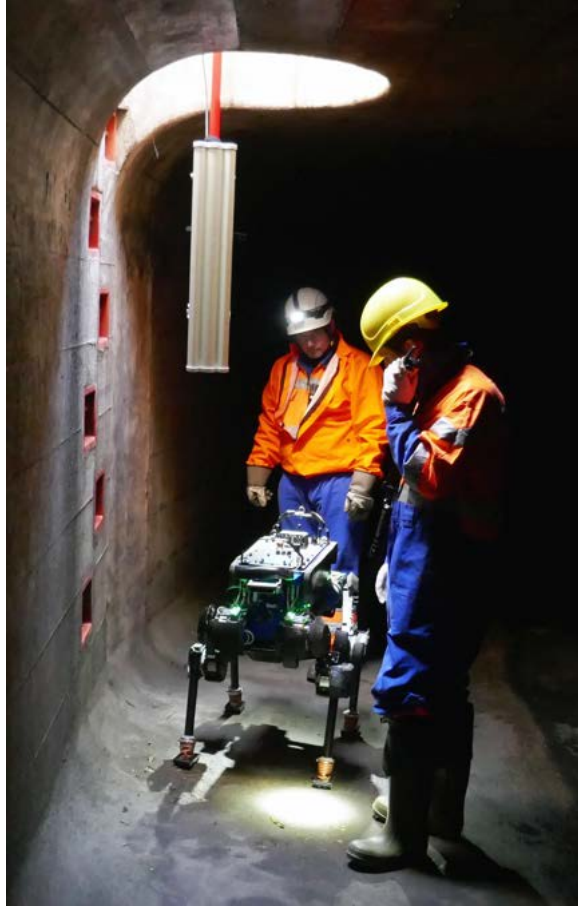
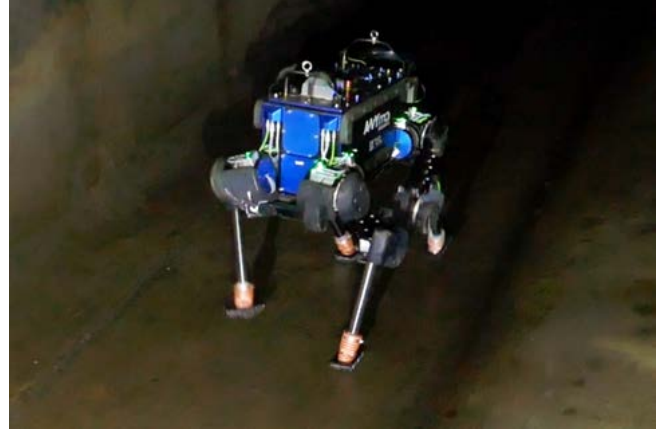
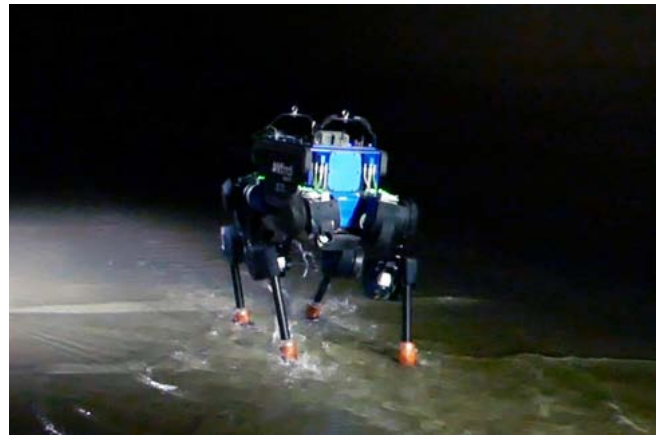
(a) *ANYmal* setup in the sewer

(b) Walking on biofilm

(c) Walking through wastewater

Figure 4: Depictions of *ANYmal* walking in the sewer. A professional sewer inspector accompanies the testing and assesses the state of the concrete.

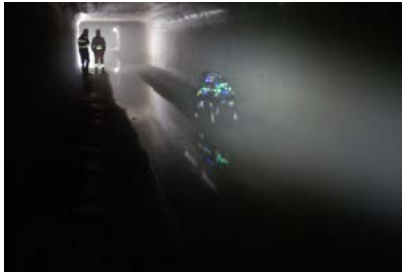
(b) The robot during mission 1 as it walks down the straight featureless tunnel. Fog can be seen in front of the robot.

The robot started in the first tunnel sewer access area and then walked down a straight section of the tunnel on the left side of the stream. This mission began in the morning when the above surface air was much cooler than the air in the tunnel. This temperature difference created fog in the sewer, as shown in Figure 10b, which was often detected as an obstacle by the LIDAR. The fog and featureless straight tunnel resulted in several artifacts in the LIDAR map (see the highlighted section of the straight tunnel in Figure 11) as well as more drift than in other missions. Since the robot walked from one utility hole to another, this mission imitates a typical inspection excursion for a human. Once the mission was complete, the robot operator directed the robot to cross the stream and walk back to the start without any interaction from the safety operator.

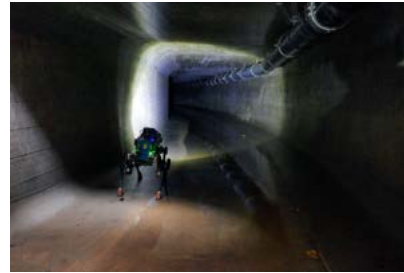
(c) Mission 2 in the second tunnel. Here the sewer is more curved and there is a large pipe suspended from the ceiling.

tunnel and the window junction. In this tunnel, a pipe was suspended from the ceiling, which, along with the curvature of the tunnel in this section, provided good features for LIDAR SLAM. After reaching the window junction, the robot operator commanded the robot to cross the stream and return to the start. After crossing the stream, the robot slipped and fell into the stream, which required operator intervention to reset the robot.

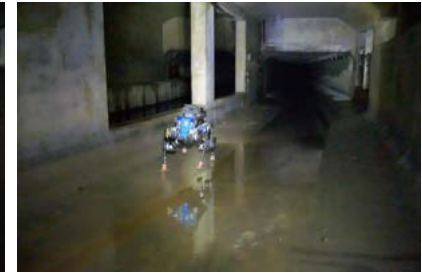
(d) View of second tunnel in direction of the window junction during mission 3. Two large windows are visible to the robot's left.

The robot started in the second tunnel sewer access area then walked towards the curved section of the tunnel and the window junction, similar to mission 2. As the robot entered the window junction, it slipped on a smooth part of concrete. The robot’s controller responded fast enough and automatically froze the joints so that the robot remained standing in place.

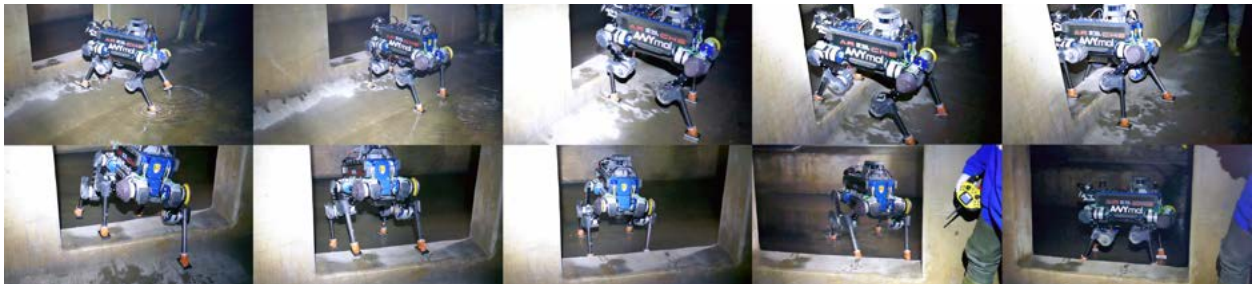
(e) The robot performing the crossing maneuver during mission 4. The robot has climbed onto the threshold and is transiting from tunnel two to tunnel one to continue the inspection.

One key motivation to use legged robots for sewer inspection is their versatility. We demonstrated this by placing the robot in the second tunnel and having it walk into the window junction. The robot operator then placed waypoints such that the robot climbed over a 15 cm step from tunnel two into tunnel one and the performed eight inspections. Because a legged robot can transit from one tunnel to another, they are much more useful than a robot confined to a single tunnel per mission.
